SUBJECT: CAFO Inspection,
FOIA Ex. 6
(Personal) Farms, Henry County, Ohio

Concentrated Animal Feeding Operation Inspection Report

Farms, Dairy and Satellite Facilities
New Bavaria, Ohio

Inspected August 16 and 17, 2016

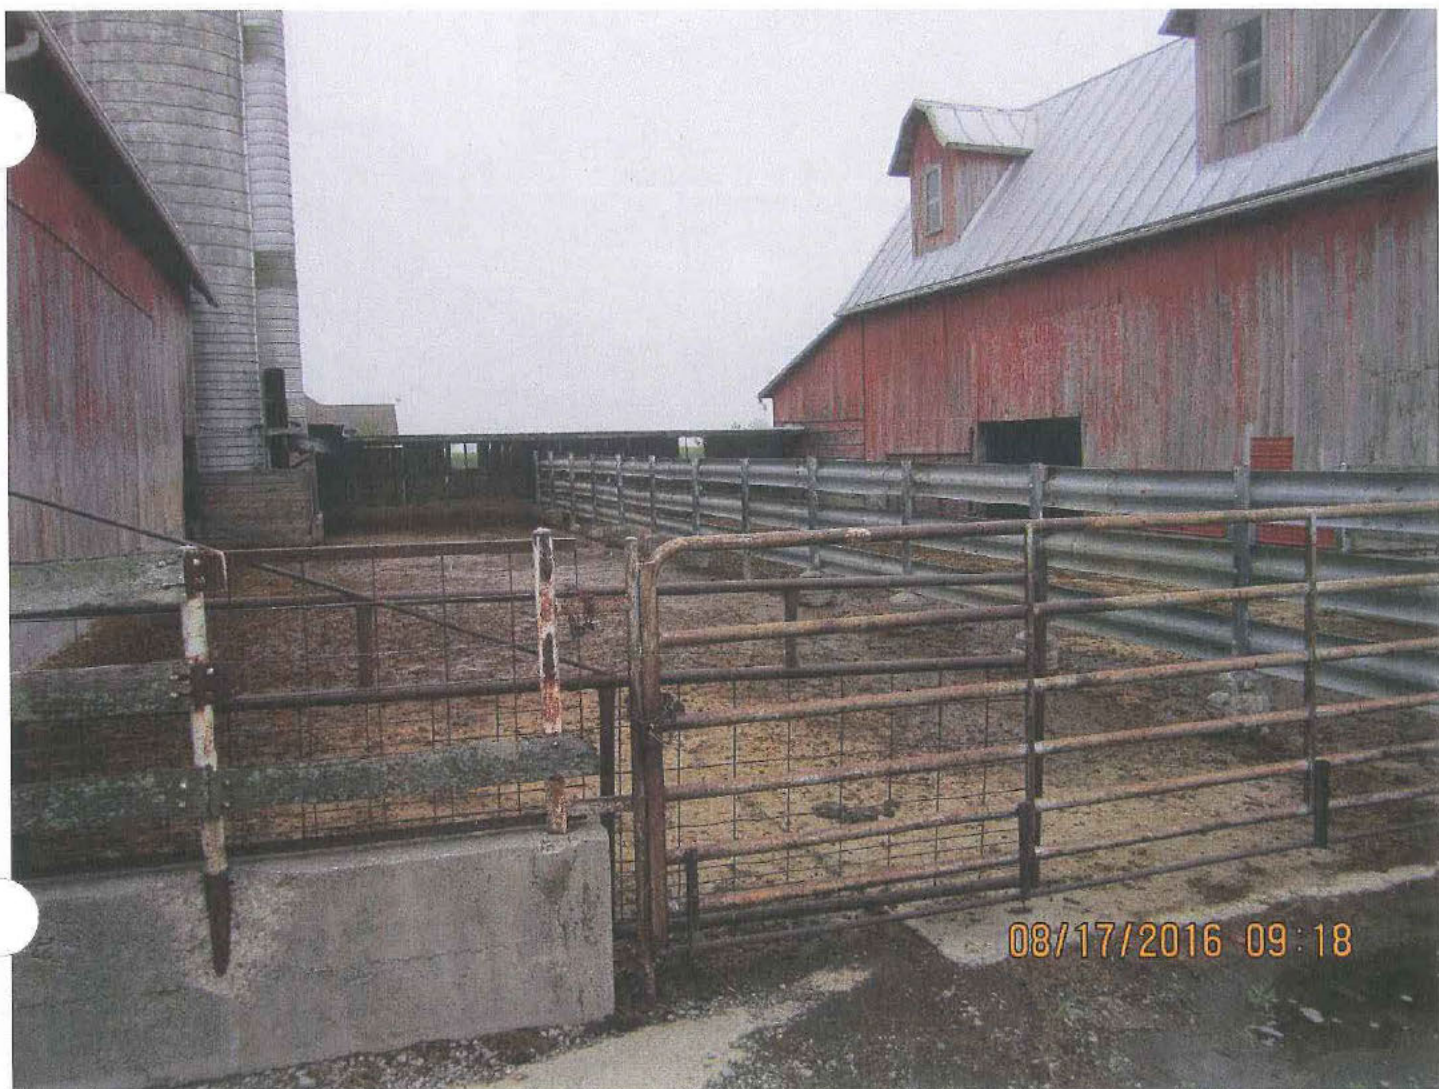
Photograph No. 35 (file IMG_0745)

Description: A fenced and divided corral is located between the heifer barn and the steer barn at the Satellite Facility. Contaminated storm water run-off from the corral flows to the southeast corner of the corral, through a drainage hole in the concrete knee wall and into a concrete reception basin.

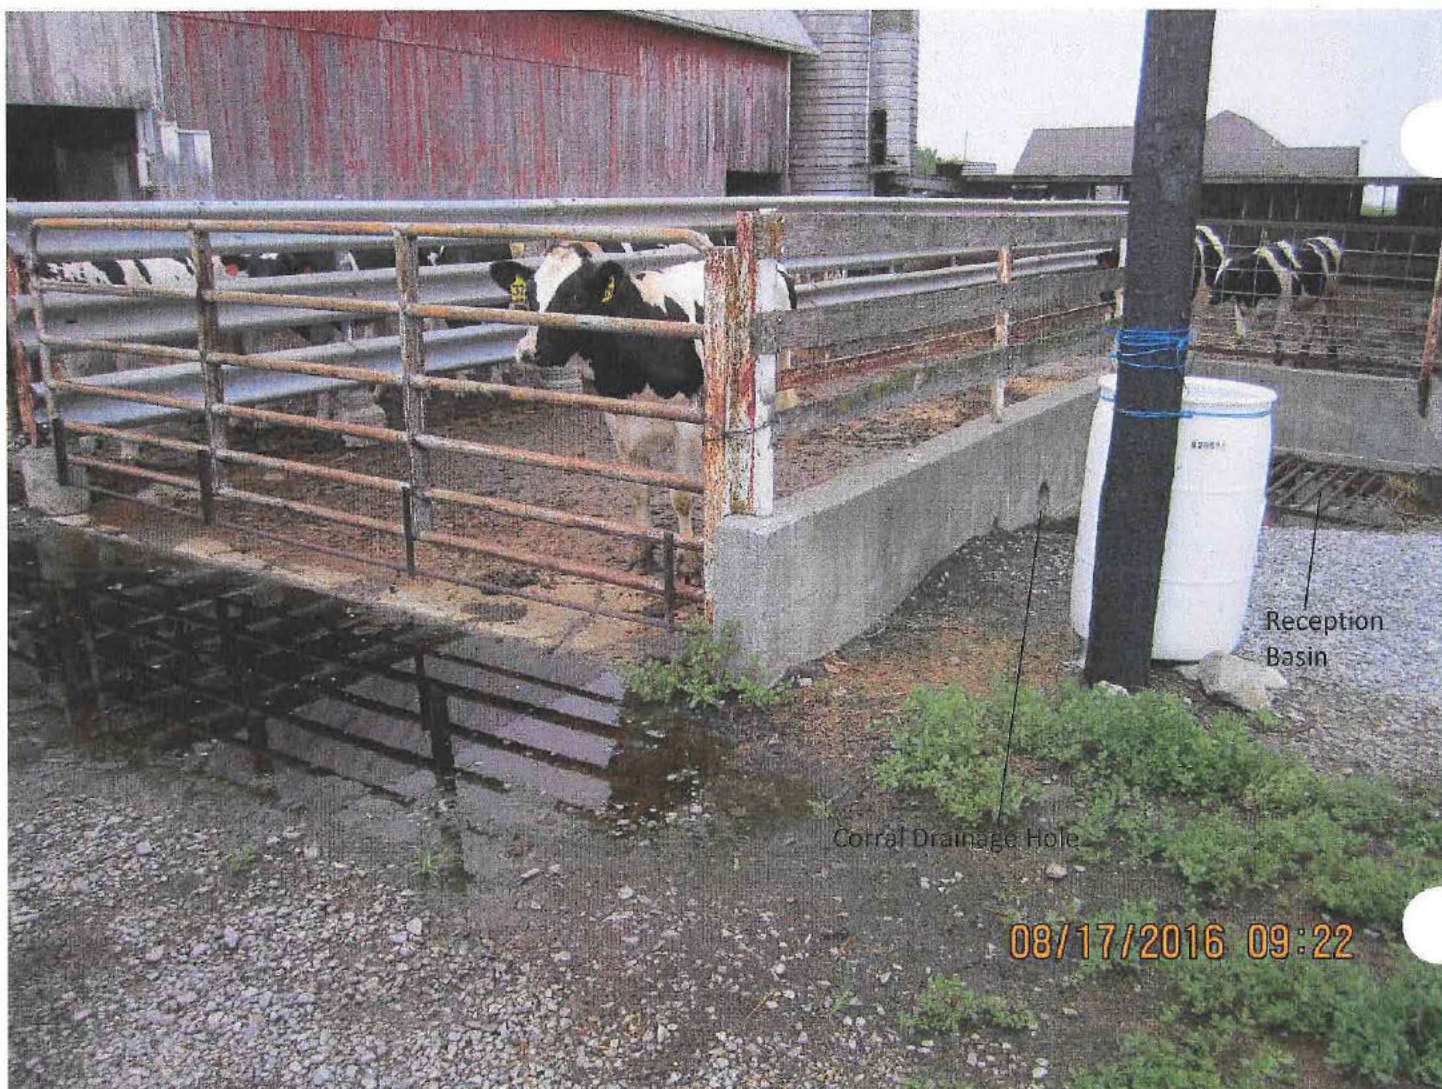
Photograph No. 36 (file IMG_0748)

Description: Storm water run-off from the corral area had pooled at the gated entrance into the corral. In this photograph the drainage hole in the knee wall and the concrete reception basin for storm water run-off can be seen.

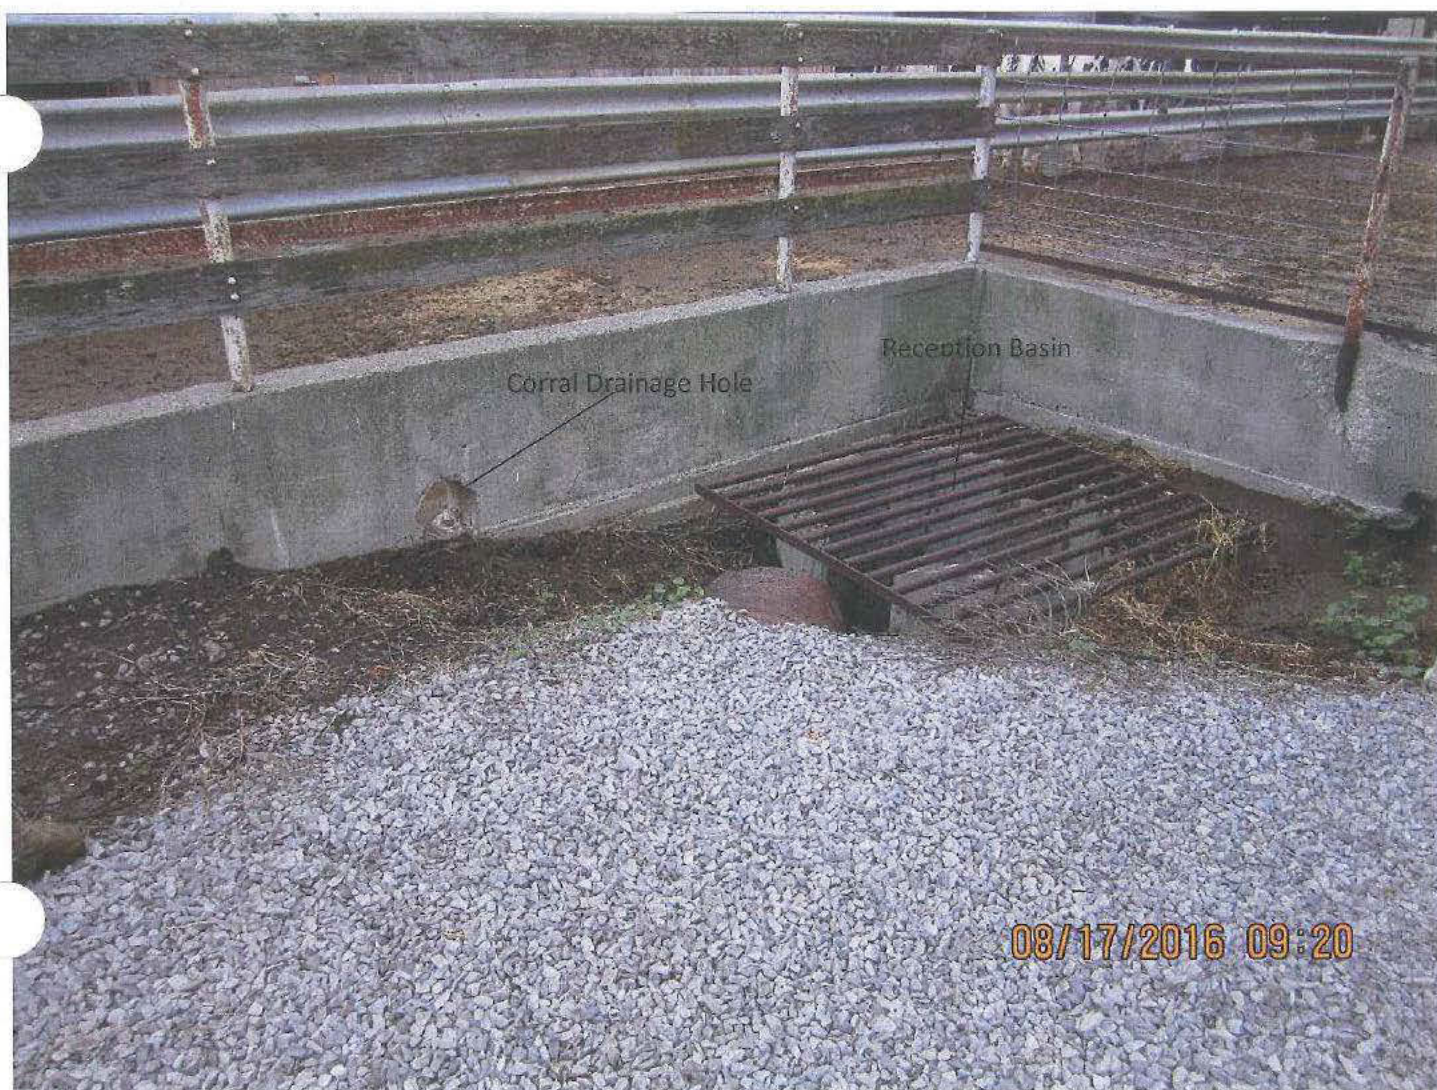
Photograph No. 37 (file IMG_0747)

Description: Drainage hole through the concrete knee wall allows contaminated storm water run-off in the corral to drain into the reception basin. The corrugated metal pipe protruding from the gravel is an old drain pipe that used to discharge surface drainage from the grass area around the barns into the reception basin. According to Ex. 6. (Personal Privacy) this drain pipe was previously disconnected and no longer discharges into the basin.

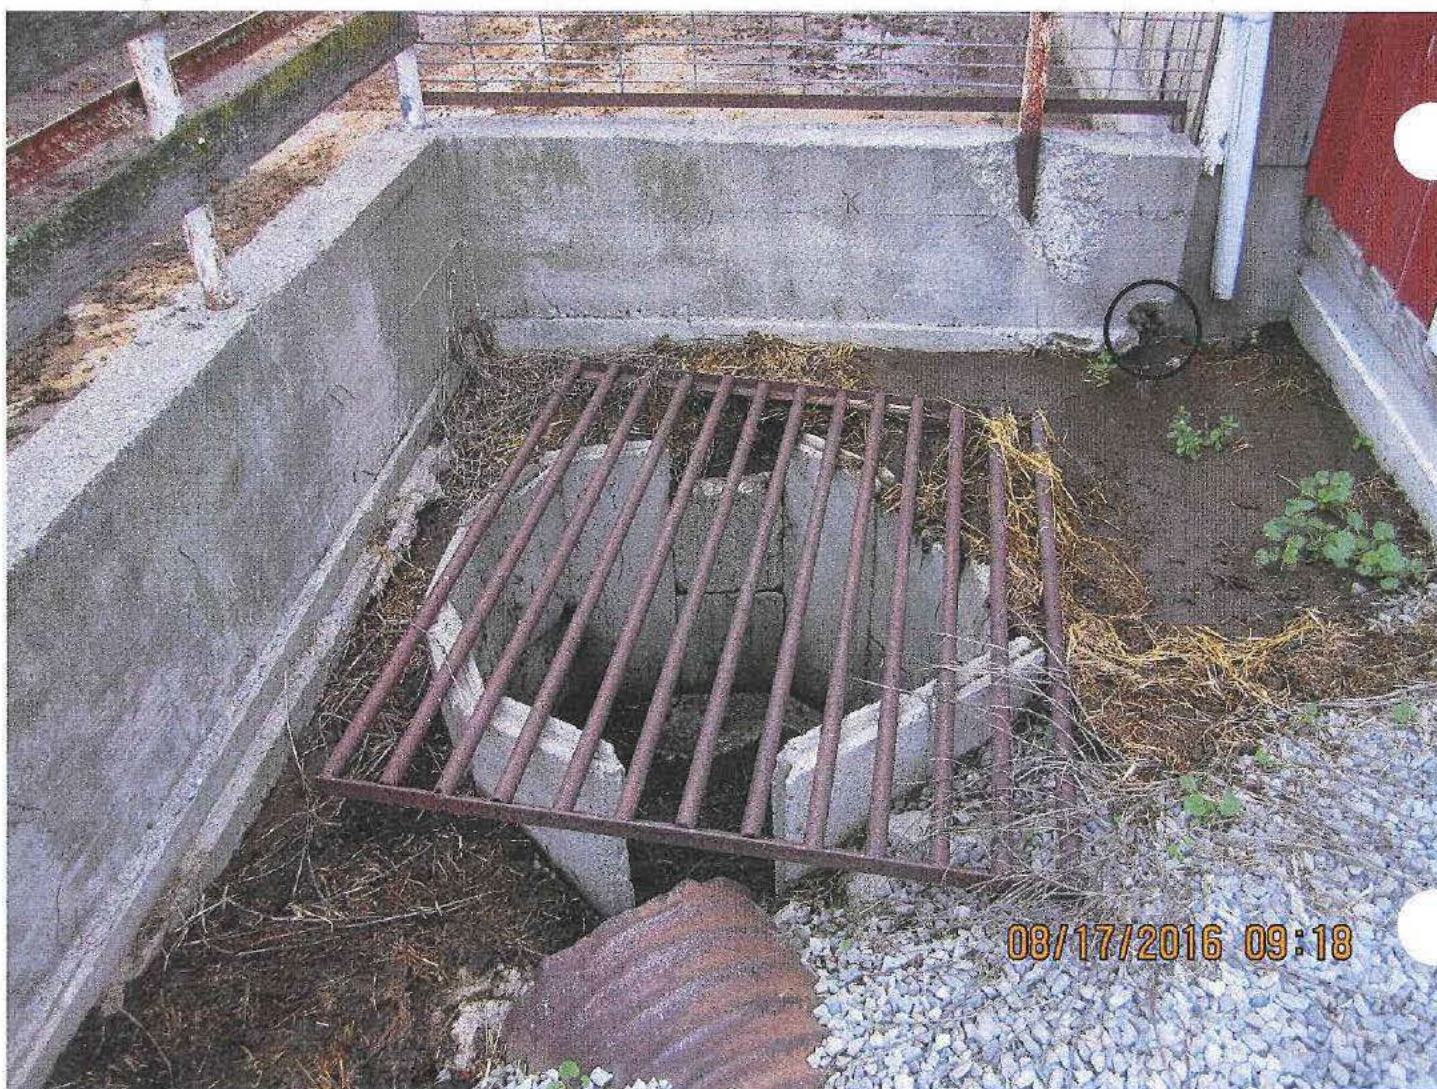
Photograph No. 38 (file IMG_0746)

Description: Contaminated storm water run-off from the east side of the corral also flows through a breach in the easternmost corner of the knee wall. The breach is circled in the photograph above. The run-off then flows into the reception basin. According to Ex. 6, (Personal Privacy) this reception basin was constructed with an outlet pipe that directs the run-off in the basin to a nearby ditch. According to topographic maps, an unnamed intermittent tributary waterway is located approximately ½ mile east/northeast from the facility.
